D-660

St. Stephen's Parish Hall
East New Market
private

Maryland Historical Trust State Historic Sites Inventory Form

Survey No. D-660

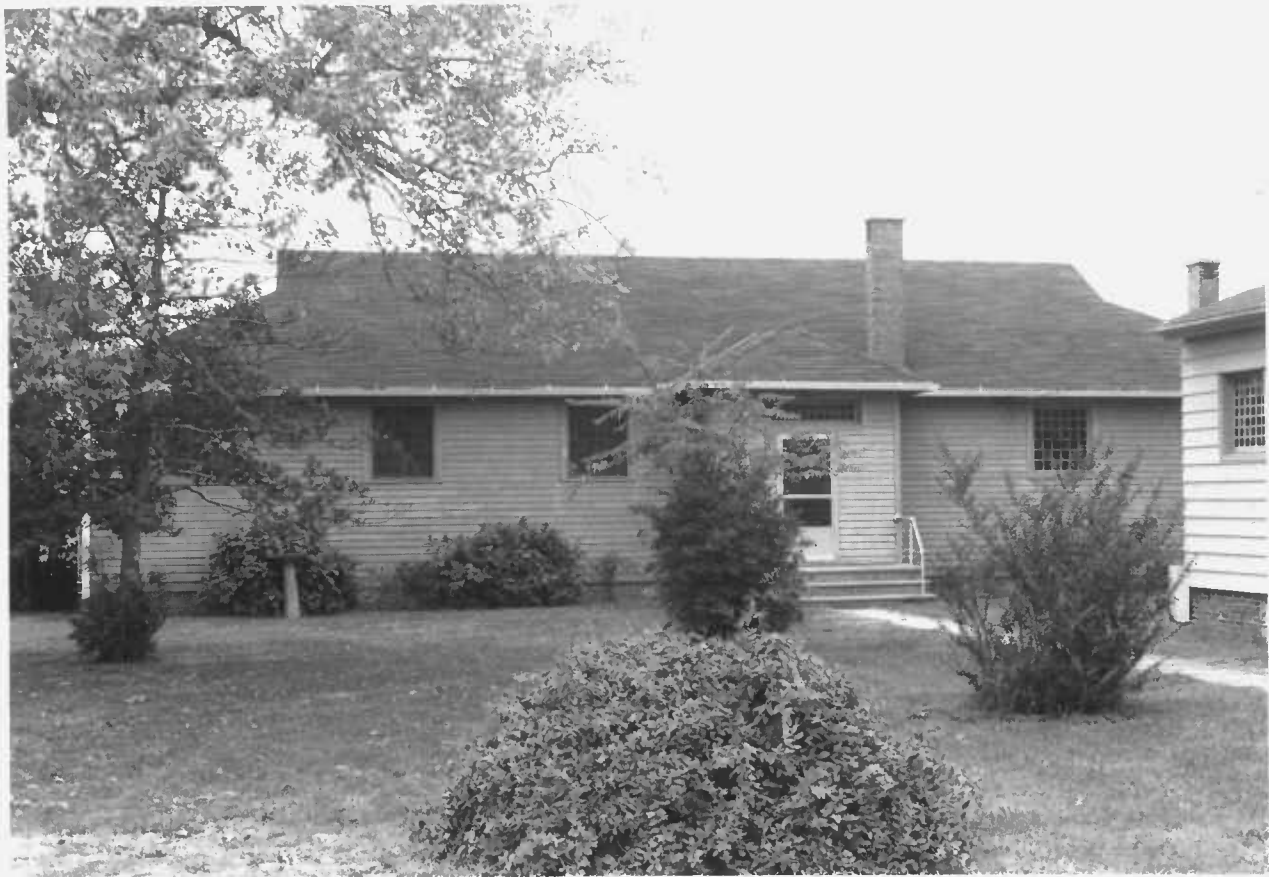
East elevation

The east (main) elevation is an asymmetrical facade with a projecting, off-center entrance vestibule covered with a hip roof. The front door is topped by a colored glass transom, and located to each side are square, multi-pane colored glass windows. A narrow brick stove stack rises through the roof of the main block immediately north of the entrance bay.

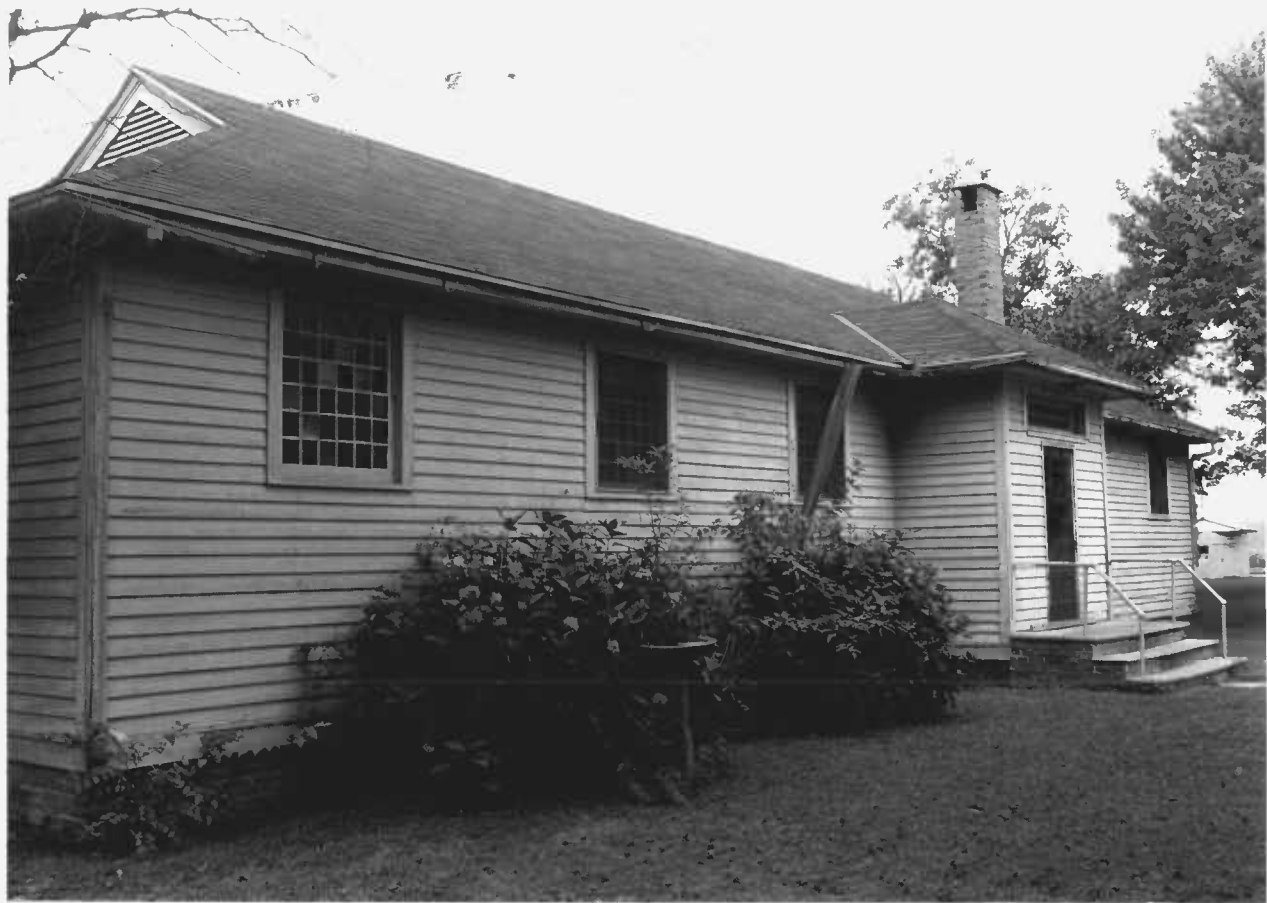
St. Stephen's Vestry house - Parish Hall
East New Market

Hip roof with small gables covered with asphalt shingles. Has corner boards with frieze--enclosed overhanging eaves. One story rectangular building with weatherboard painted gray. Six-bay front and back.

Front entrance has cement steps with handrails. Over the fourth bay, which extends from the main building, is a two-row colored glass transom*. Three inside chimneys (front, back, right side). Side entrance has cement steps with handrails. Double wooden bottom doors with two-row colored glass transom*. Three bays on left and two bays on right.
